Manhole Inspection Summary

Manhole # S55AA_006MH

Insp Date: **7/29/08 3:47 PM**

Location Address: **3625 mcelderry st**

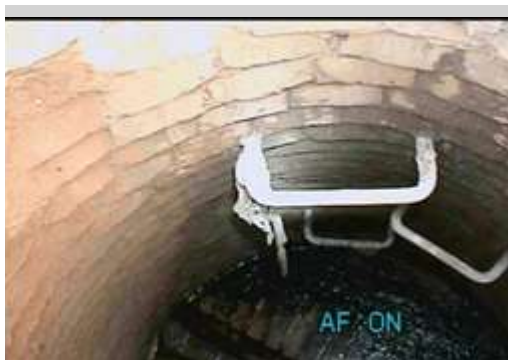
Miscellaneous

Steps

Count: **3** Missing: **0** ☐ Corroded

steps

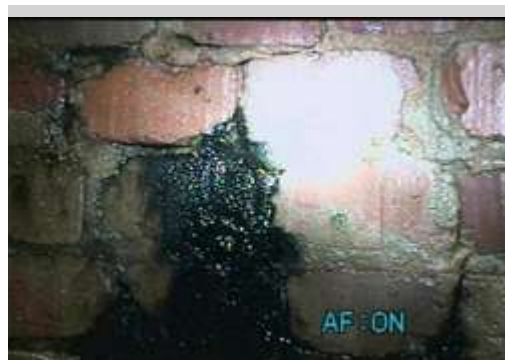
Defect 4

Infiltration: ☐ None ☐ Joint ☐ Cracks ☐ Mortar ☐ Roots ☒ Wall

infiltration

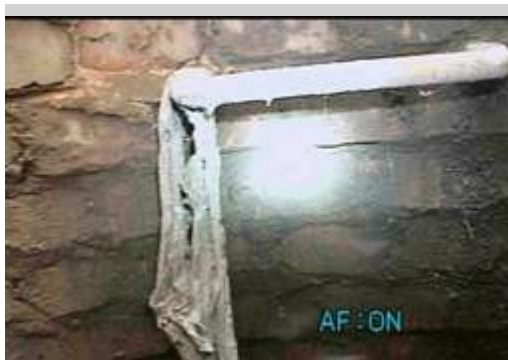
Defect 3

☒ Evidence Of Surcharge Depth: **4.1** (ft.) ☐ Active Surcharge Present

evidence of surcharge

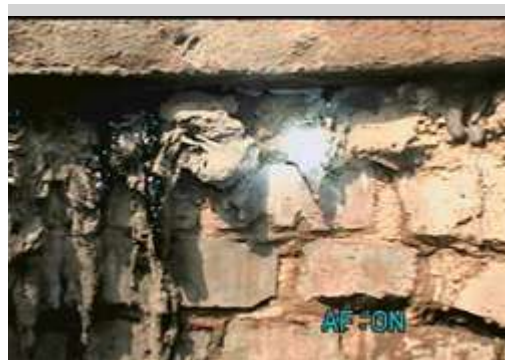
Defect 1

Condition: ☐ Sound ☐ Cracked ☐ Root Intrusion ☒ Loose Brick ☒ Deteriorated

chimney loose bricks, deteriorated, frame adj

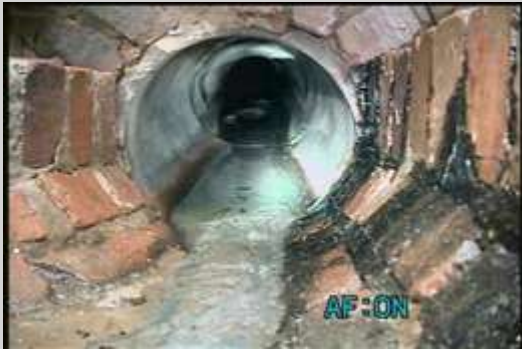
12 O'Clock Outflow

8 in. Circular Gravity Sewer
Pipe Out @ 12 O'Clock

Invert Depth: 7.50 (ft.) Flow Characteristics: **Fast**

Infiltration: **None** Pipe Seal Cond: **Unknown**

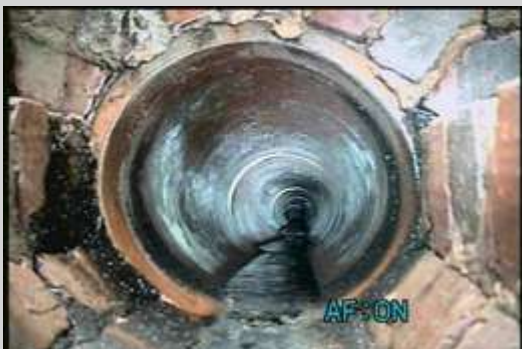
6 O'Clock Inflow

8 in. Circular Gravity Sewer
Pipe In @ 6 O'Clock

Invert Depth: 6.92 (ft.) Flow Characteristics: **Fast**

Infiltration: **None** Pipe Seal Cond: **Unknown**

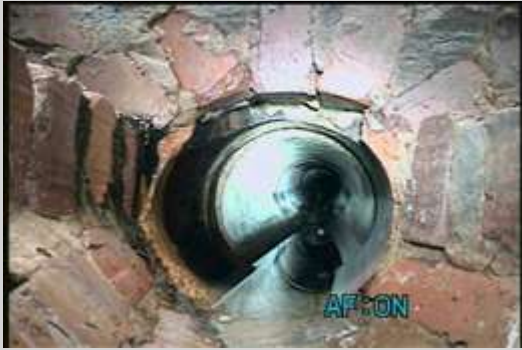
9 O'Clock Inflow

8 in. Circular Gravity Sewer
Pipe In @ 9 O'Clock

Invert Depth: **7.25** (ft.) Flow Characteristics: **Fast**

Infiltration: **None**
